Improving the reliability of the resist outgas contamination test

Robert F. Berg, Shannon B. Hill, Thomas B. Lucatorto, Charles Tarrio
National Institute of Standards and Technology, Gaithersburg, Maryland, USA
EUVL Symposium, , 27-29 October 2014, Washington, DC, USA

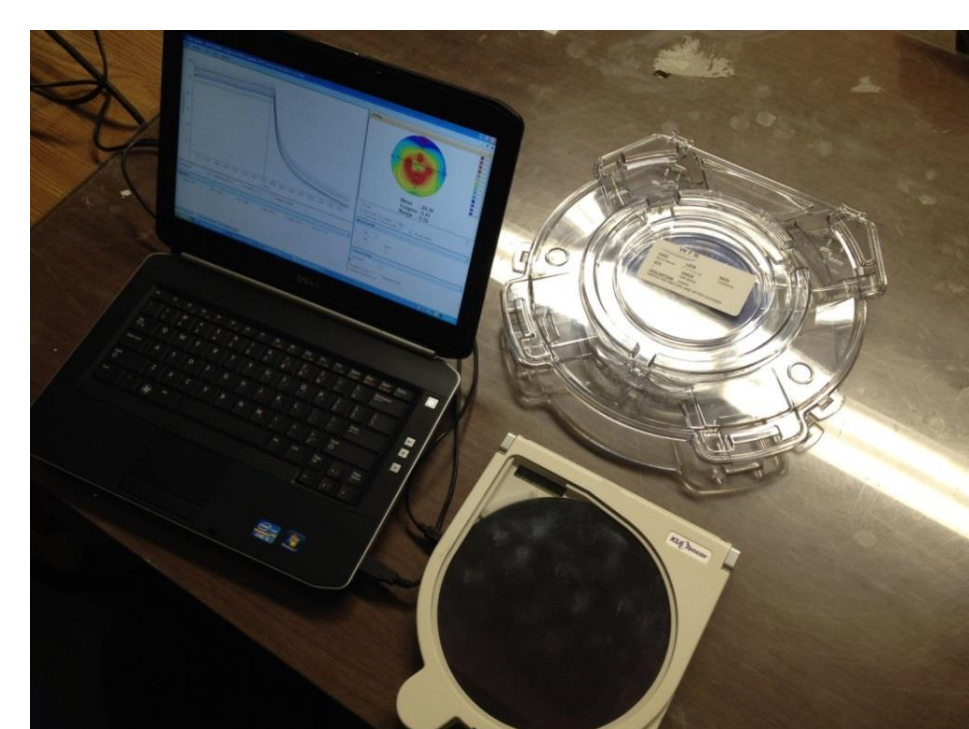
Commercial instrumented wafer (courtesy of EIDEC)

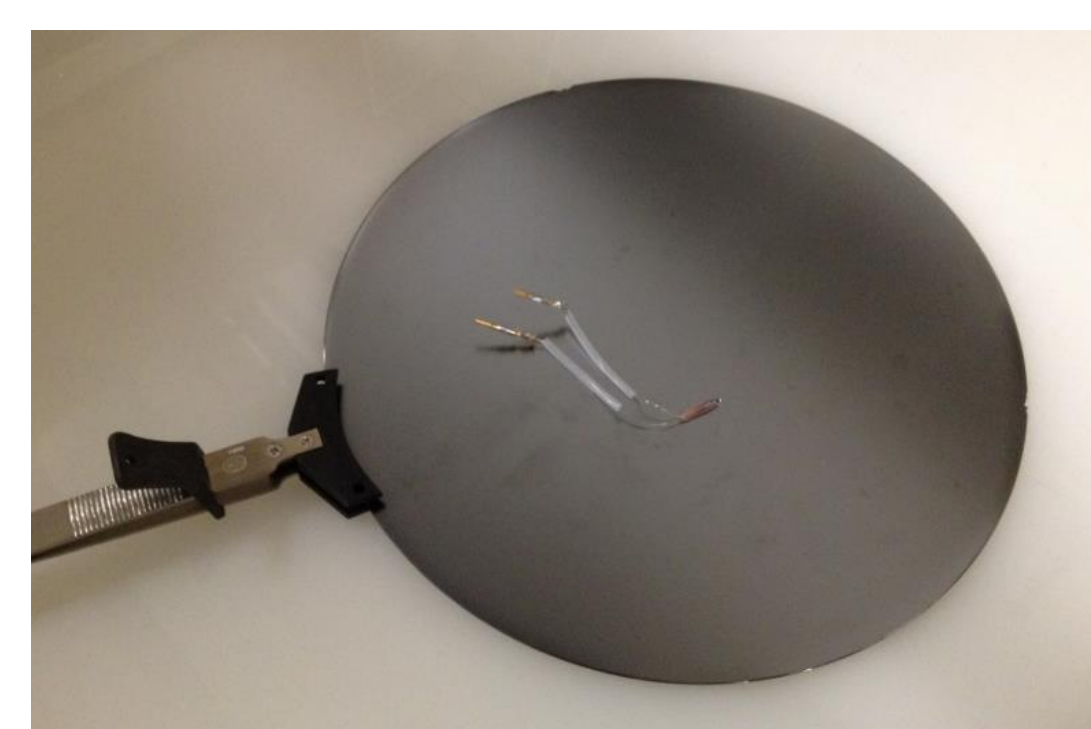
Thermistor glued to wafer
